Proposal for a pedestrian Refuge on Moreton Road Buckingham.

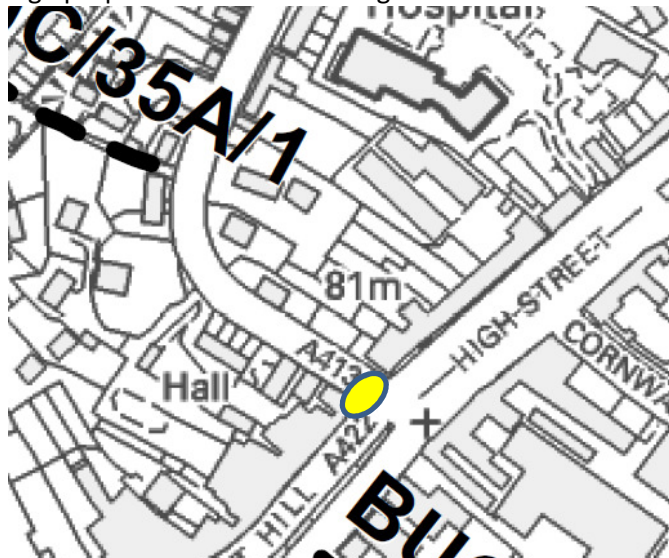
Outside the Kings Head public house near the junction of Moreton Road and High Street.

Fig1 proposed location for refuge.

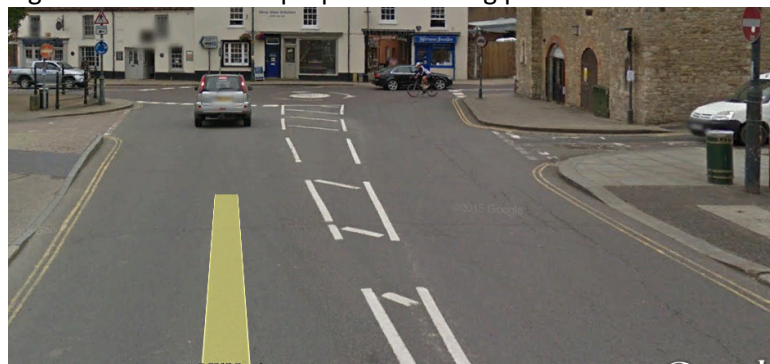
Fig2 street view at the proposed crossing point.

- **Location** crossing point outside Kings Head pub already has dropped kerbs.
- **Type** of crossing - an island refuge may be possible. There are already hatch marks in the centre of the road. There is enough footpath room on the town centre side to widen the road if this was needed. If because of the width of the road an island refuge was not possible then Pelican or zebra would have to be the alternative.
- **Foot Traffic**
- Extensively used serving all directions (see section footfall)

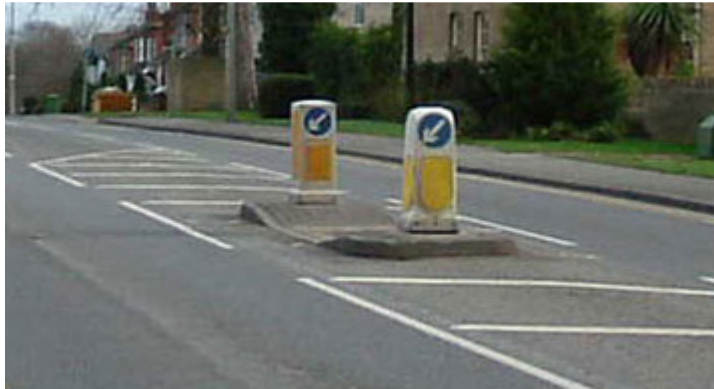
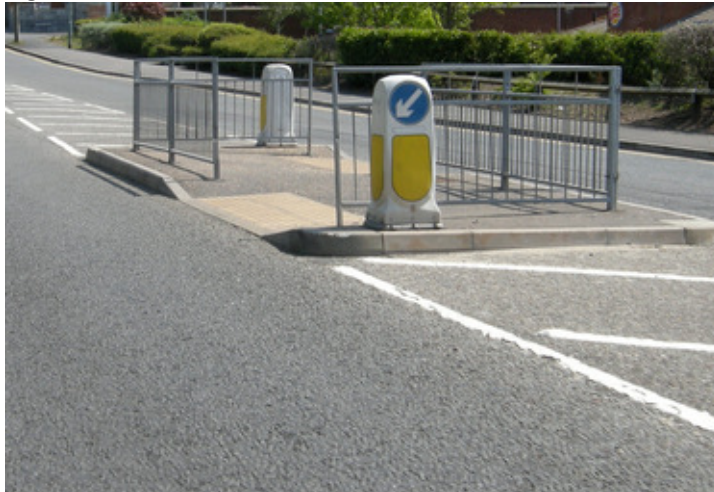
- Refuge islands must be a minimum of 1.2 meters wide, however this is usually raised to 1.8 meters in Bristol to accommodate pushchairs and wheelchairs more easily
- Normally, road widths must be at least 4 to 4.5 meters either side of the refuge (if the location is on a bend and large motor vehicles are expected, this must be increased)
- Parking restrictions may need to be imposed on approach and near to the refuge
